# NUCLEAR WEAPONS EFFECTS TESTS OF BLAST TYPE SHELTERS

A Documentary Compendium of Test Reports

Civil Effects Branch, Division of Biology and Medicine  
U. S. Atomic Energy Commission, Washington  
June 1969

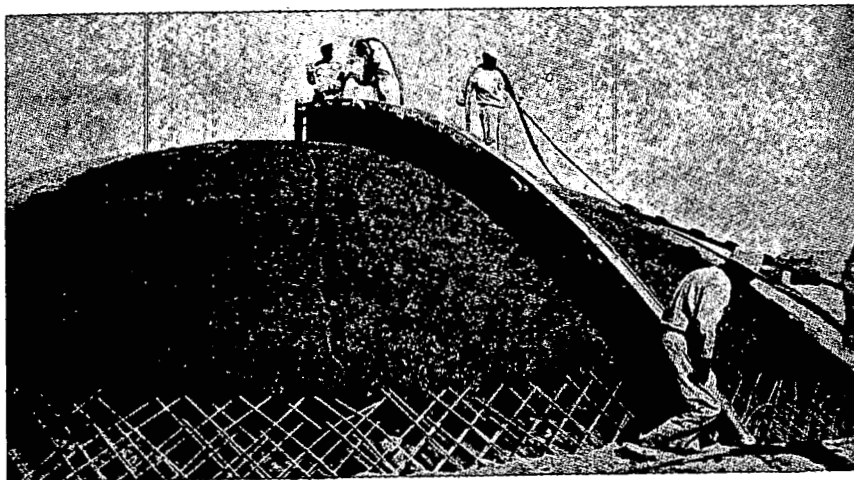
Fig. 8—Shotcreting of earth-berm form for responding concrete dome.

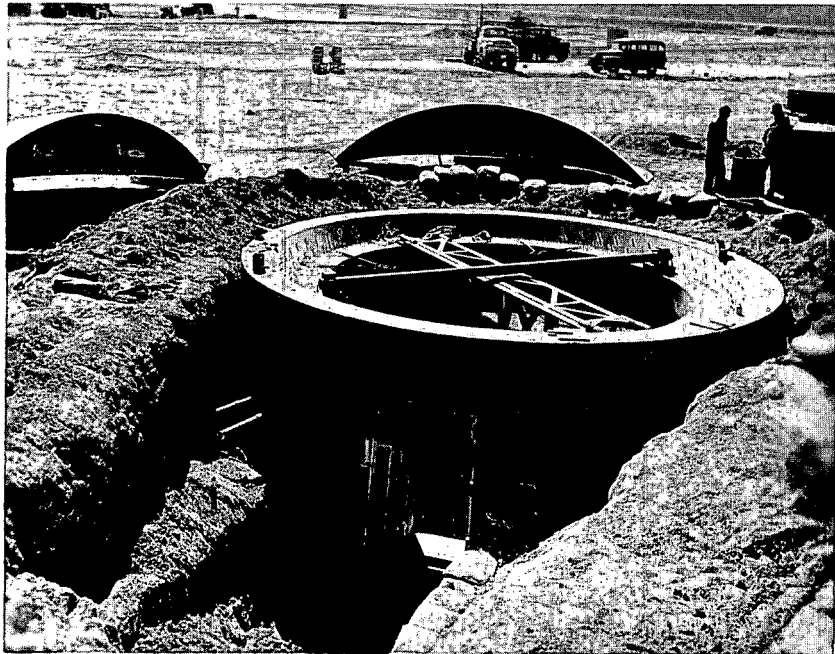
Fig. 9—Foundation for aluminum dome. Two halves of shell are in background.

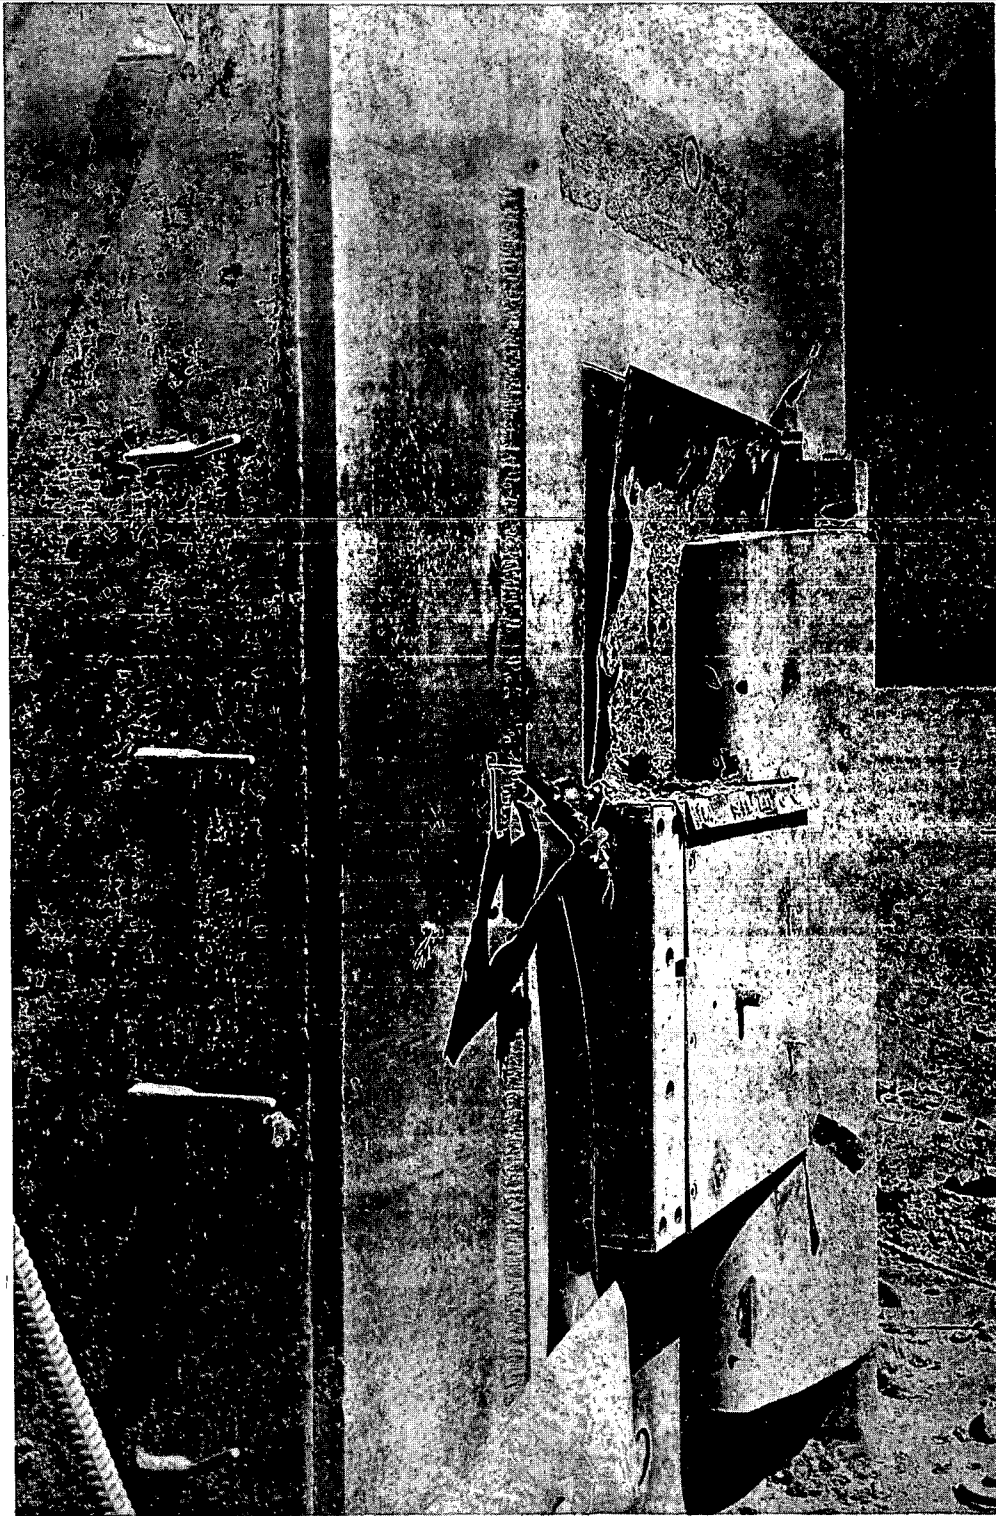
Fig. 6—Close-up view of front face from south showing damage to light-gauge finish plates and hardware, postshot.

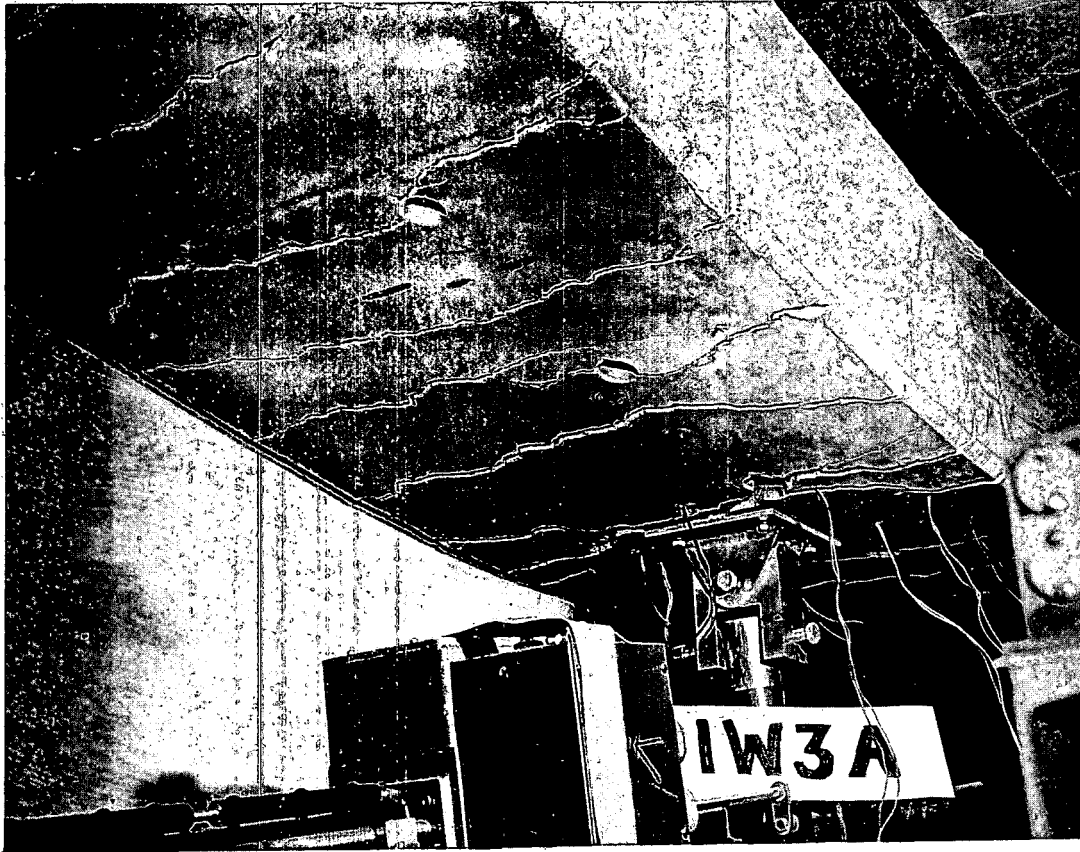
Fig. 5—Photograph showing tension cracks beneath slab IW3A.

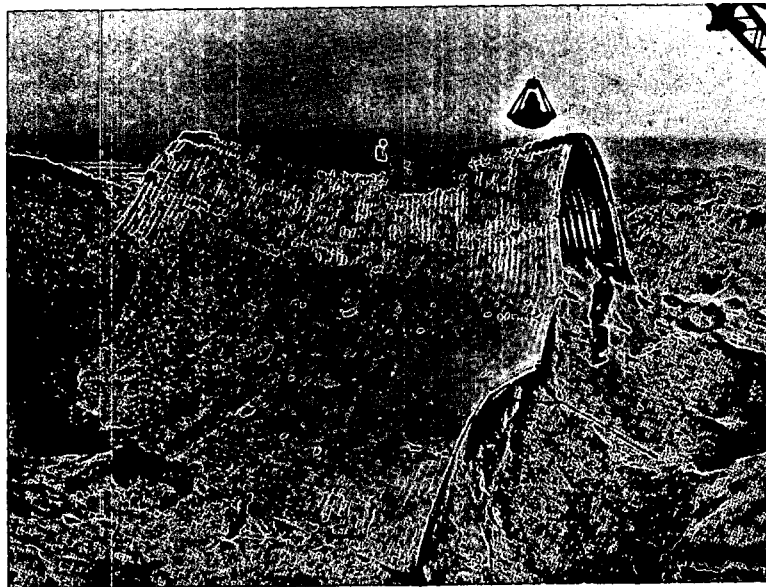
Fig. 15—Structure 3.2d, infiltration of sand after end-wall failure; looking toward GZ.

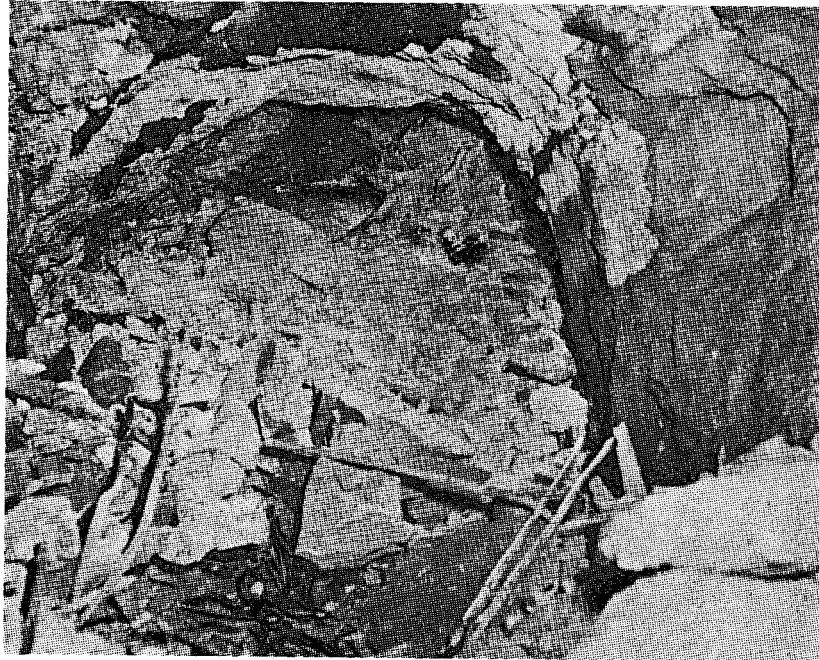
Fig. 6—Point of closure, drift U12b.02, Tamalpais event.
